# Manhole Inspection Summary

Manhole # S19A\_\_035MH

Insp Date: **10/18/07 9:23 AM**

**Location** Address: **624 HARLEM-ALLEY-EDMONDSON** Cross Street: **PAYSON-APPLETON**

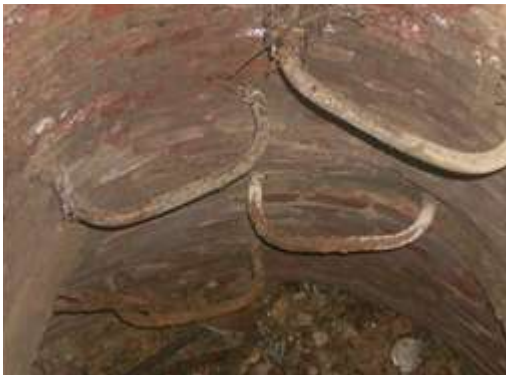
Defect 2

**Steps** Count: **4** Missing: **0** ☒ **Corroded**

CORRODED STEPS

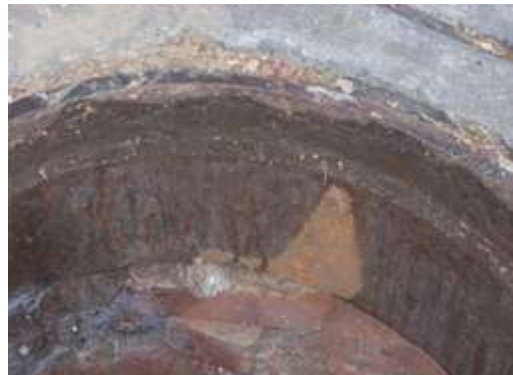
Defect 1

**Chimney / Frame Adjustment** ☒ Exists Material: **Brick** ☐ Parged Height: **3** (in.)  
Condition: ☐ Sound ☐ Cracked ☐ Root Intrusion ☒ **Loose Brick** ☐ Deteriorated  
Infiltration: ☒ None ☐ Joint ☐ Cracks ☐ Mortar ☐ Roots ☐ Wall

LOOSE CHIMNEY BRICKS

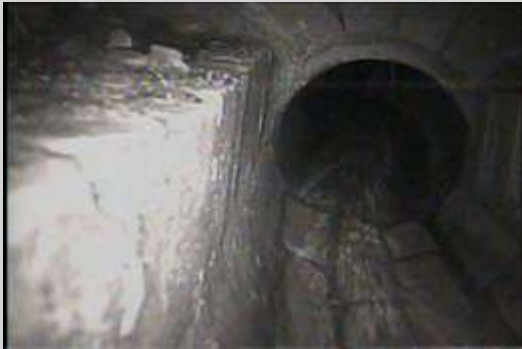
12 O'Clock Outflow

8 in. Circular Gravity Sewer  
Pipe Out @ 12 O'Clock

Pipe Height: **8.4** (in.) Rod and Bar (Angled)  
Pipe Material: **Clay** ☐ Pipe Lined  
Invert Depth: **7.69** (ft.) Flow Characteristics: **Fast**  
Deposits: ☒ None ☐ Mud ☐ Sludge ☐ Debris ☐ Grease  
Silt Depth: (in.) Deposits Extent:  
Infiltration: **None** Pipe Seal Cond: **Sound**

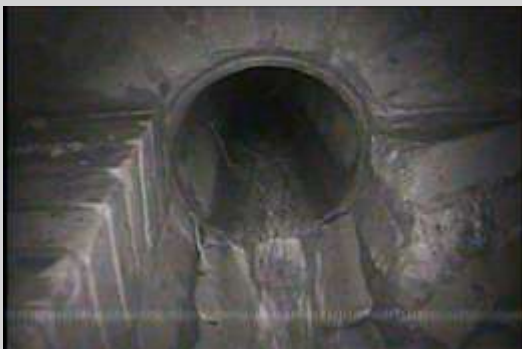
6 O'Clock Inflow

8 in. Circular Gravity Sewer  
Pipe In @ 6 O'Clock

Pipe Height: **7.2** (in.) Rod and Bar (Angled)  
Pipe Material: **Clay** ☐ Pipe Lined  
Invert Depth: **7.41** (ft.) Flow Characteristics: **Fast**  
Deposits: ☒ None ☐ Mud ☐ Sludge ☐ Debris ☐ Grease  
Silt Depth: (in.) Deposits Extent:  
Infiltration: **None** Pipe Seal Cond: **Sound**

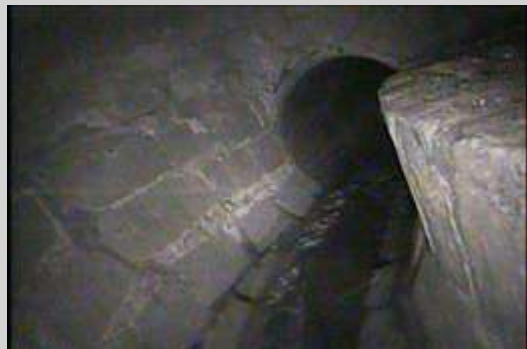
9 O'Clock Inflow

8 in. Circular Gravity Sewer

Pipe In @ 9 O'Clock

Pipe Height: **7.2** (in.) Rod and Bar (Angled)

Invert Depth: **7.62** (ft.) Flow Characteristics: **Slow**

Infiltration: **None** Pipe Seal Cond: **Sound**
